Global Clinical Case Contest 2019-2020

Student:
Aziz Çalışkan DDS
Tutor:
İsmail S. Sadıkoğlu DDS, PhD
University:
Near East University
Country:
Turkey

Introduction to the case

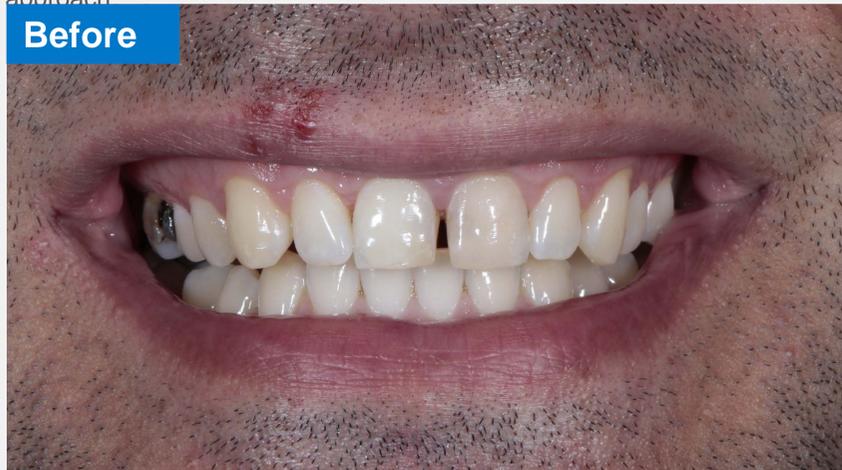
Before

Initial smile before the treatment

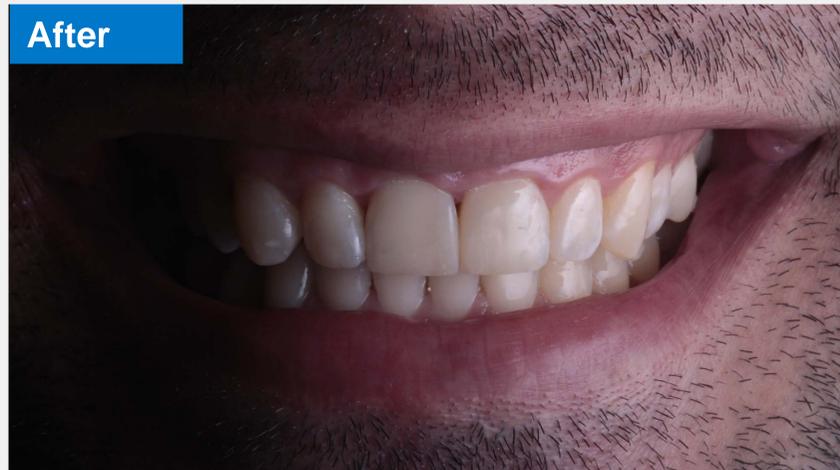
After

Change of smile after the treatment

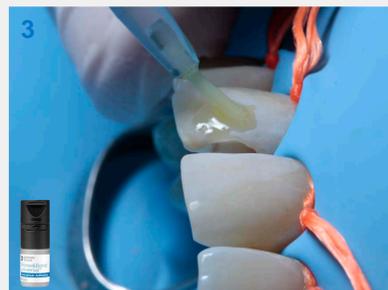
Etching Phase

Etching enamel surfaces with %37 orthophosphoric acid gel to achieve maximum adhesion

Shade selection was done prior to all other procedures to avoid tooth dehydration caused misselection of the color. After the rubber-dam isolation, old restorations and secondary caries were removed. Following etching step with %37 orthophosphoric acid, Prime&Bond Universal adhesive was applied. For the left central, SDR Plus U® was applied from 5 mm below of the cemento-enamel junction to get support from the root canal and in order to strengthen remaining tooth structure. Palodent® sectional matrix band placed vertically to ensure proper emergence profile thus to maintain good periodontal health. Ceram.x SphereTEC One® A2 shade veneer was applied to restore teeth alignment, color and form. Finally, finishing and polishing was done with the Enhance® PoGo® system.

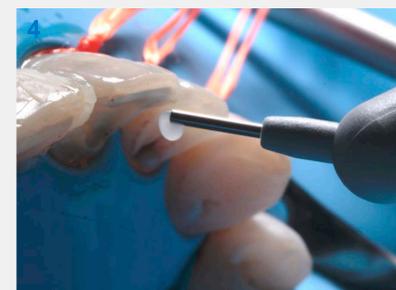
Adhesive Phase

Applying Prime&Bond Universal adhesive to etched surfaces

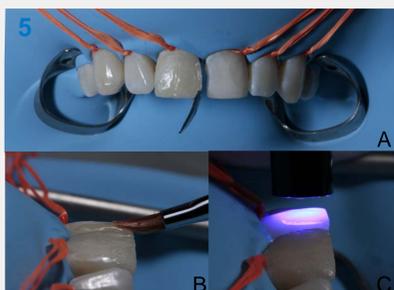
SDR Plus U® application instead of a fiber post

Strengthening remaining tooth structure by inserting SDR Plus U® into the entire endodontic space which starts from the 5 mm below of the cervical line.

Combining minimally invasive approaches with proper material selection is indispensable to today's preventive dentistry philosophy. Maximum amount of tooth structure should be preserved while achieving esthetic and functional treatment outcomes. With this perspective, SDR Plus® bulk fill composite was used instead of using a post to avoid unnecessary root dentin removal in the present case. One shade resin composite Ceram.x SphereTEC One® gives us a chance to reduce our chair side time in these Covid-19 pandemic days which is an important factor during daily practice not only for the patient but also the dentist.

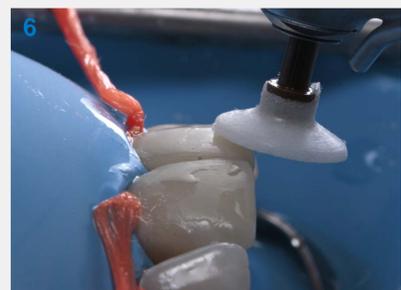
Restoration steps on labial surfaces

A: Palodent® sectional matrix band application to achieve proper emergence profile, B: Application of the composite with a composite brush, C: Polymerization of the composite restoration

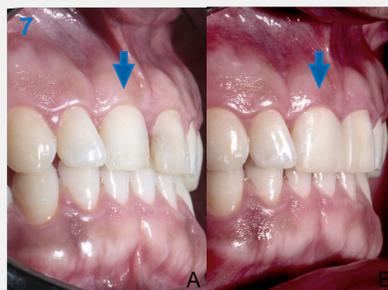
Finishing and polishing

Enhance® PoGo® system were used for finishing and polishing of the restorations

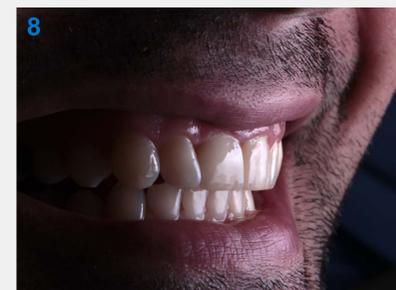
Correction of the tooth alignment

A A2 shade Ceram.x SphereTEC One® veneer restoration applied to correct the right central's retrusive position. A: Before the treatment and B: After the treatment
